ARMY AVIATION TEST BOARD FORT RUCKER ALA
TEST OF T53-L-13 ENGINE (S/N LE-14083).(U)
NOV 68

SUBJECT: Letter Report of Test of T53-L-13 Engine (S/N LE-14083).
USATECOM Project No. 4-6-0150-05

DETAILED TEST RESULTS

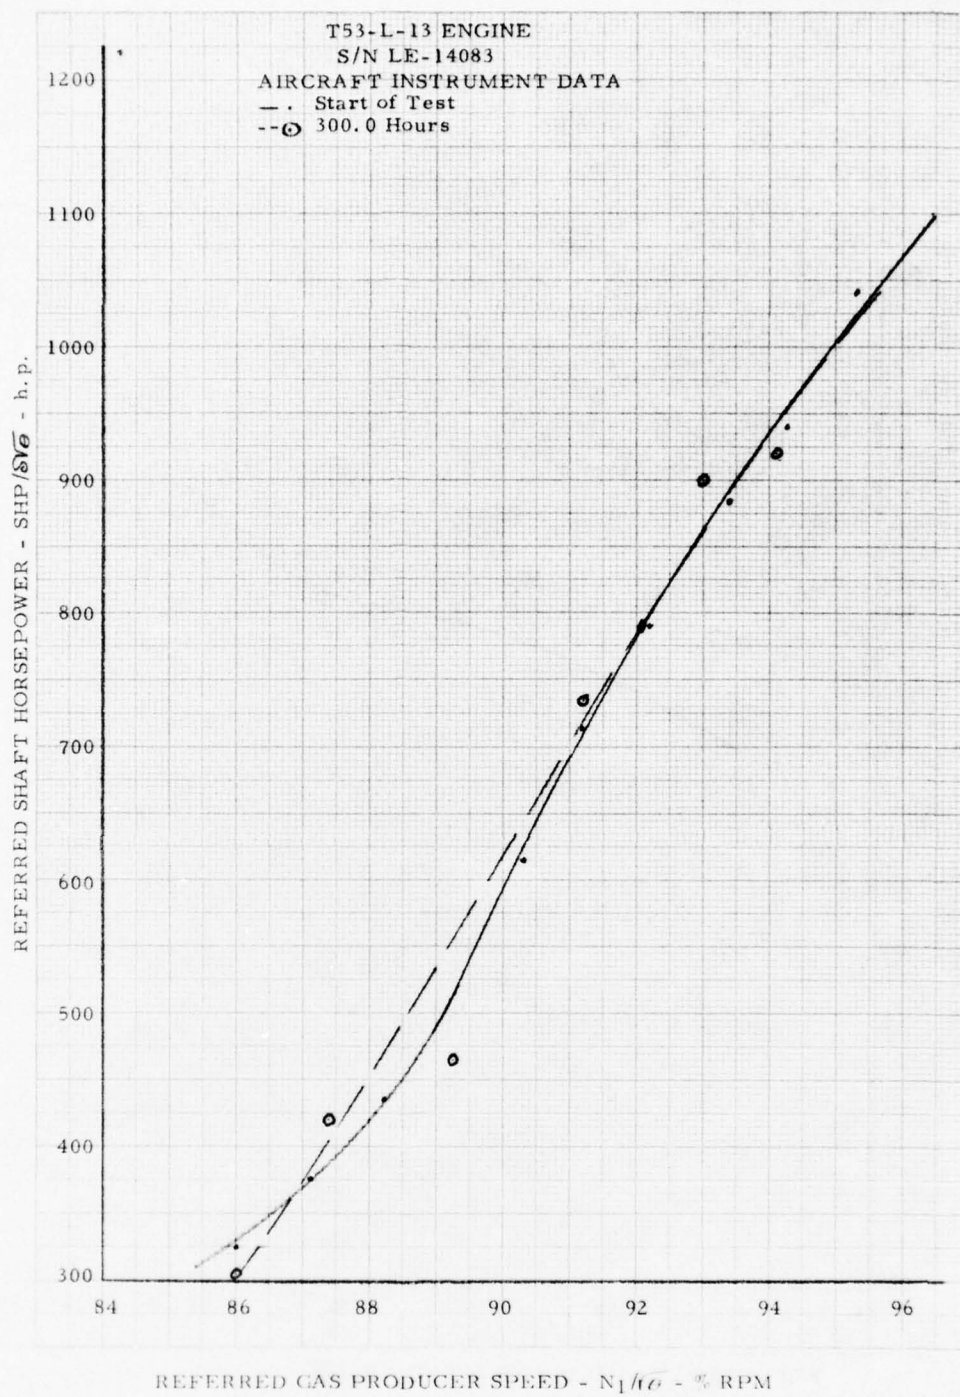
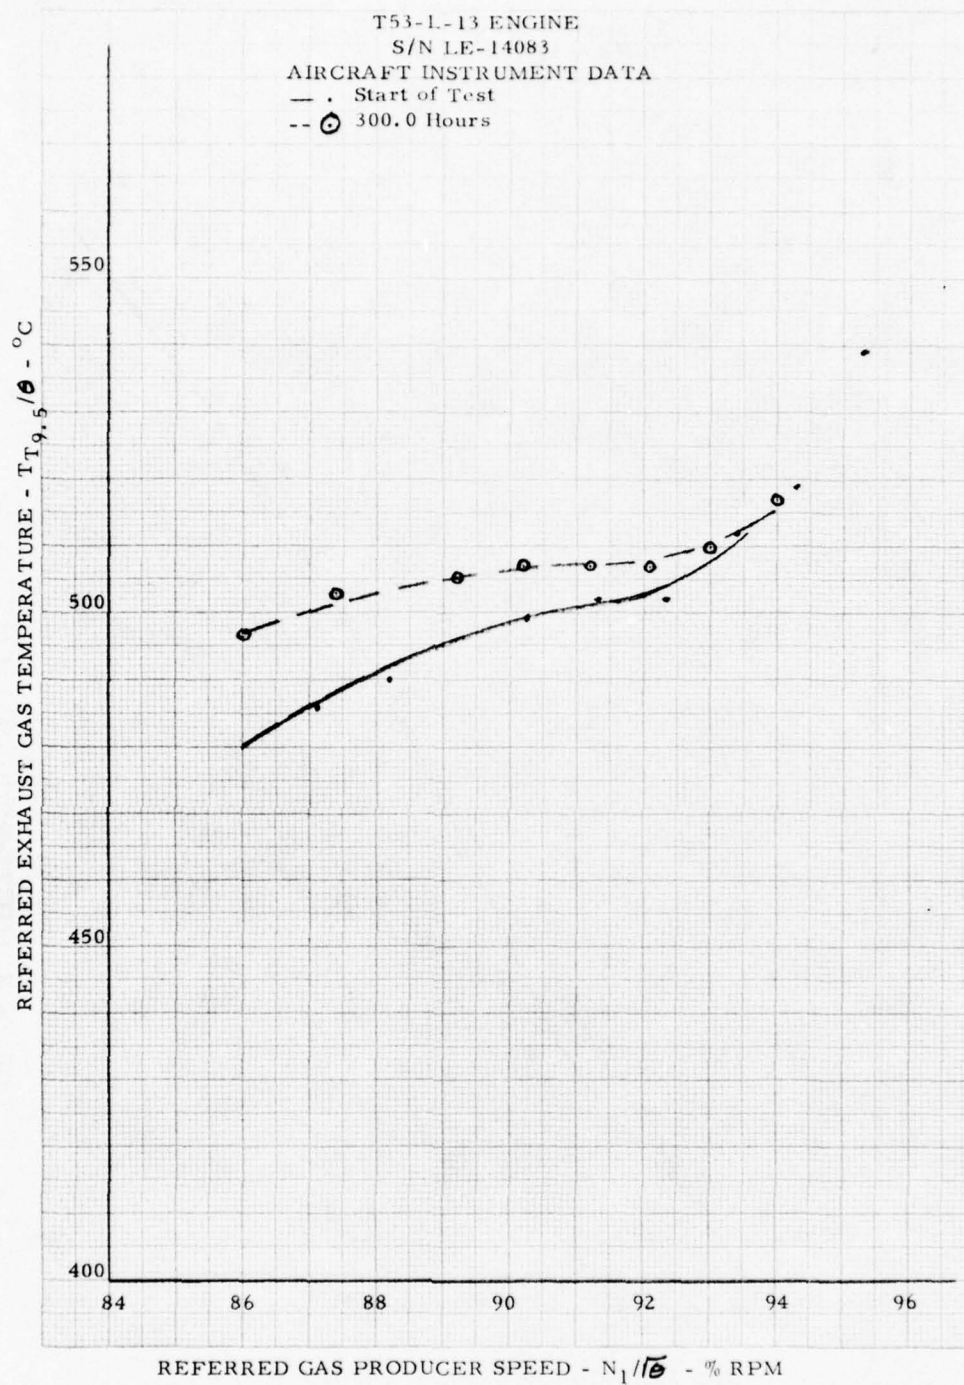
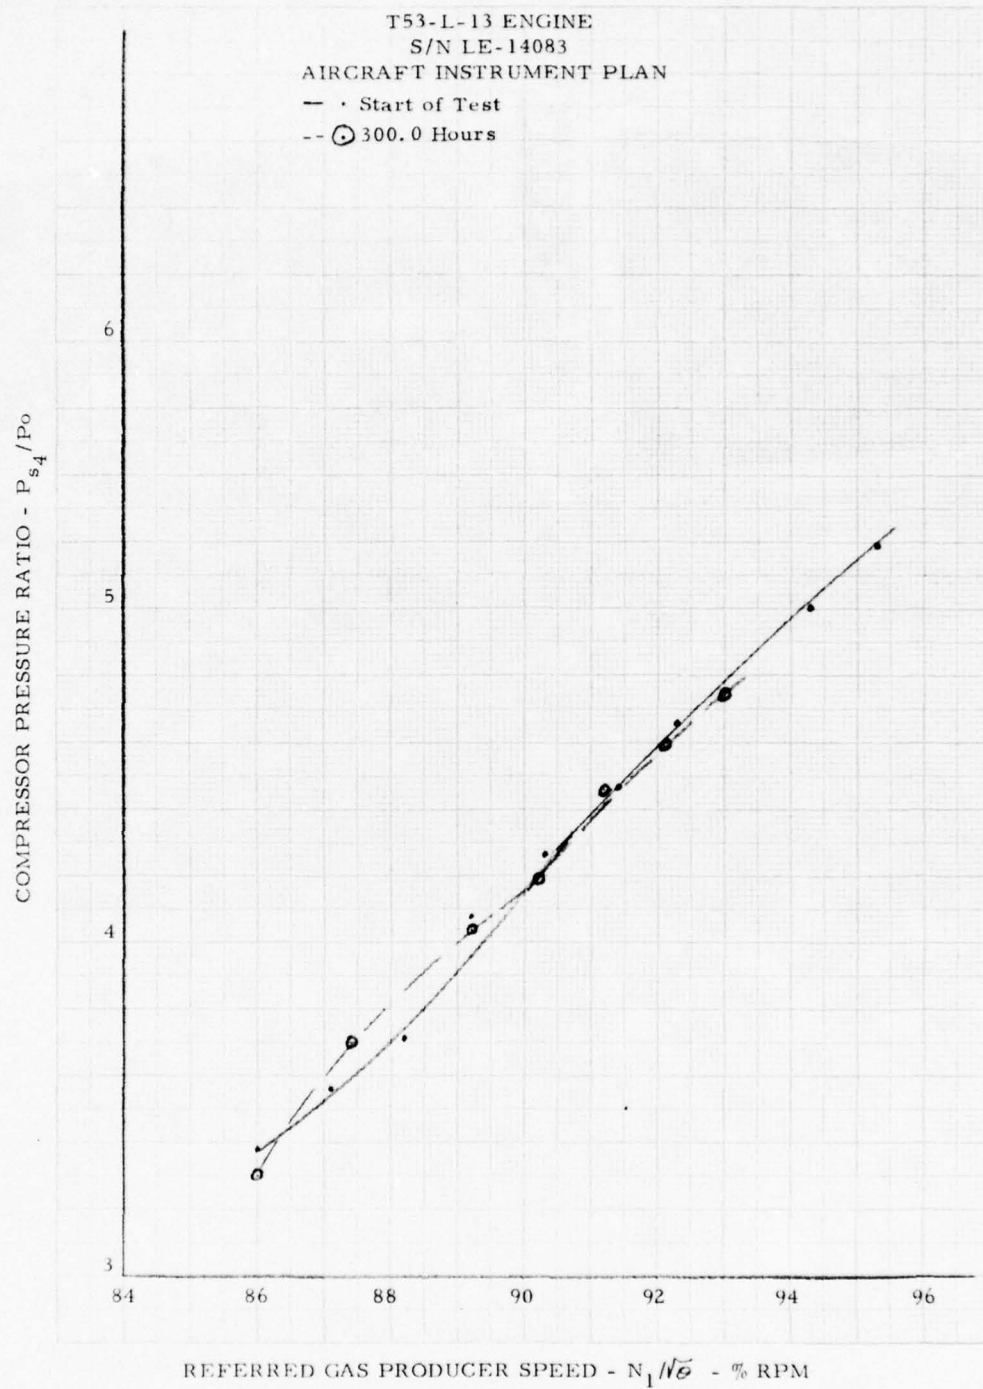
b. Figures 1, 2, and 3 show engine performance prior to the 300-hour inspection compared to performance at the start of the test.

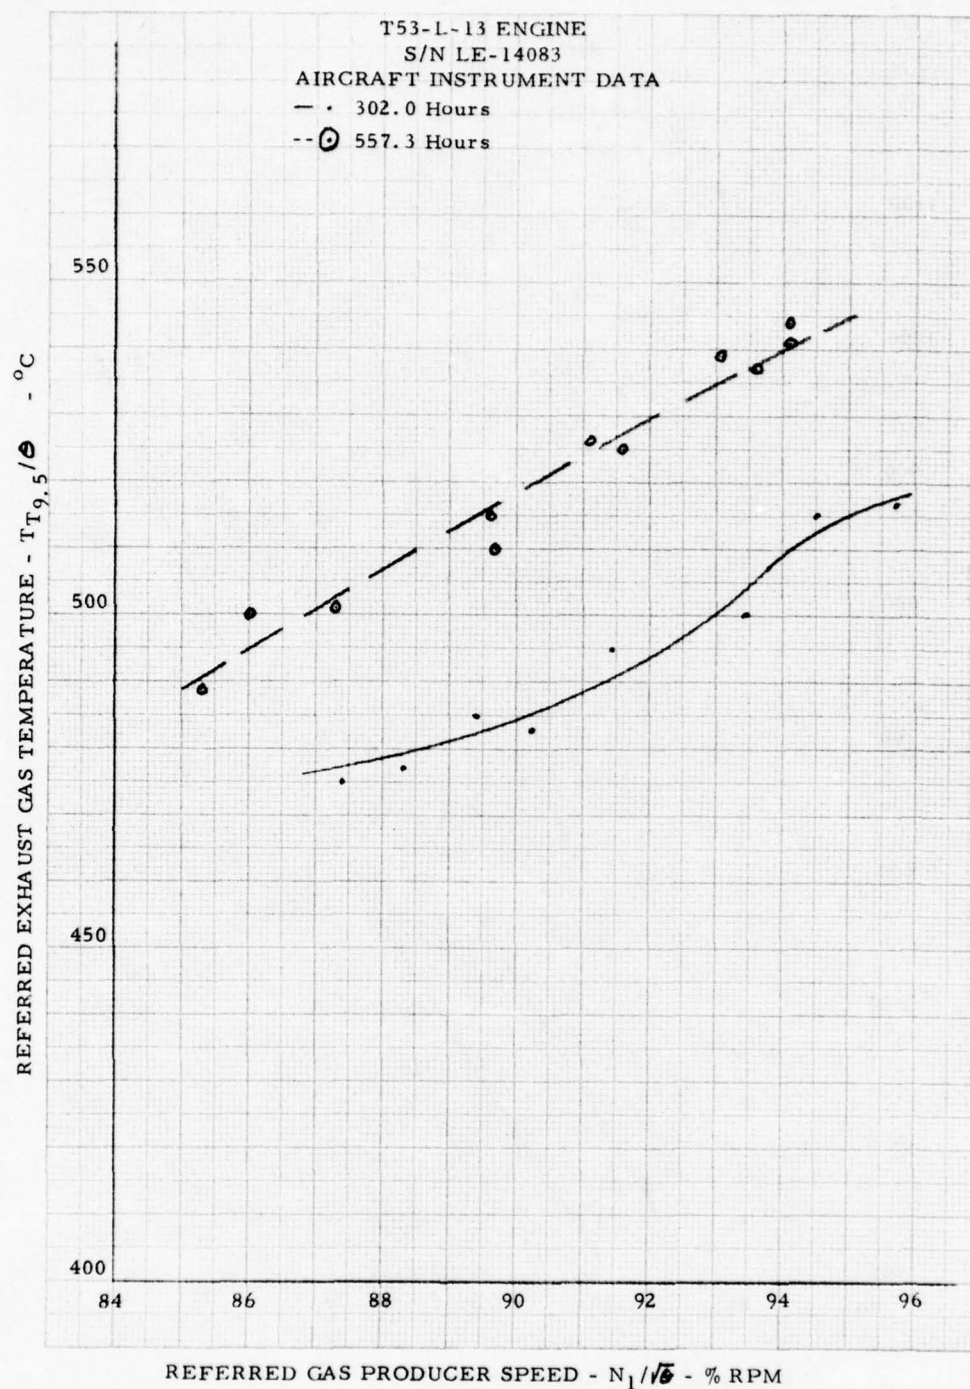
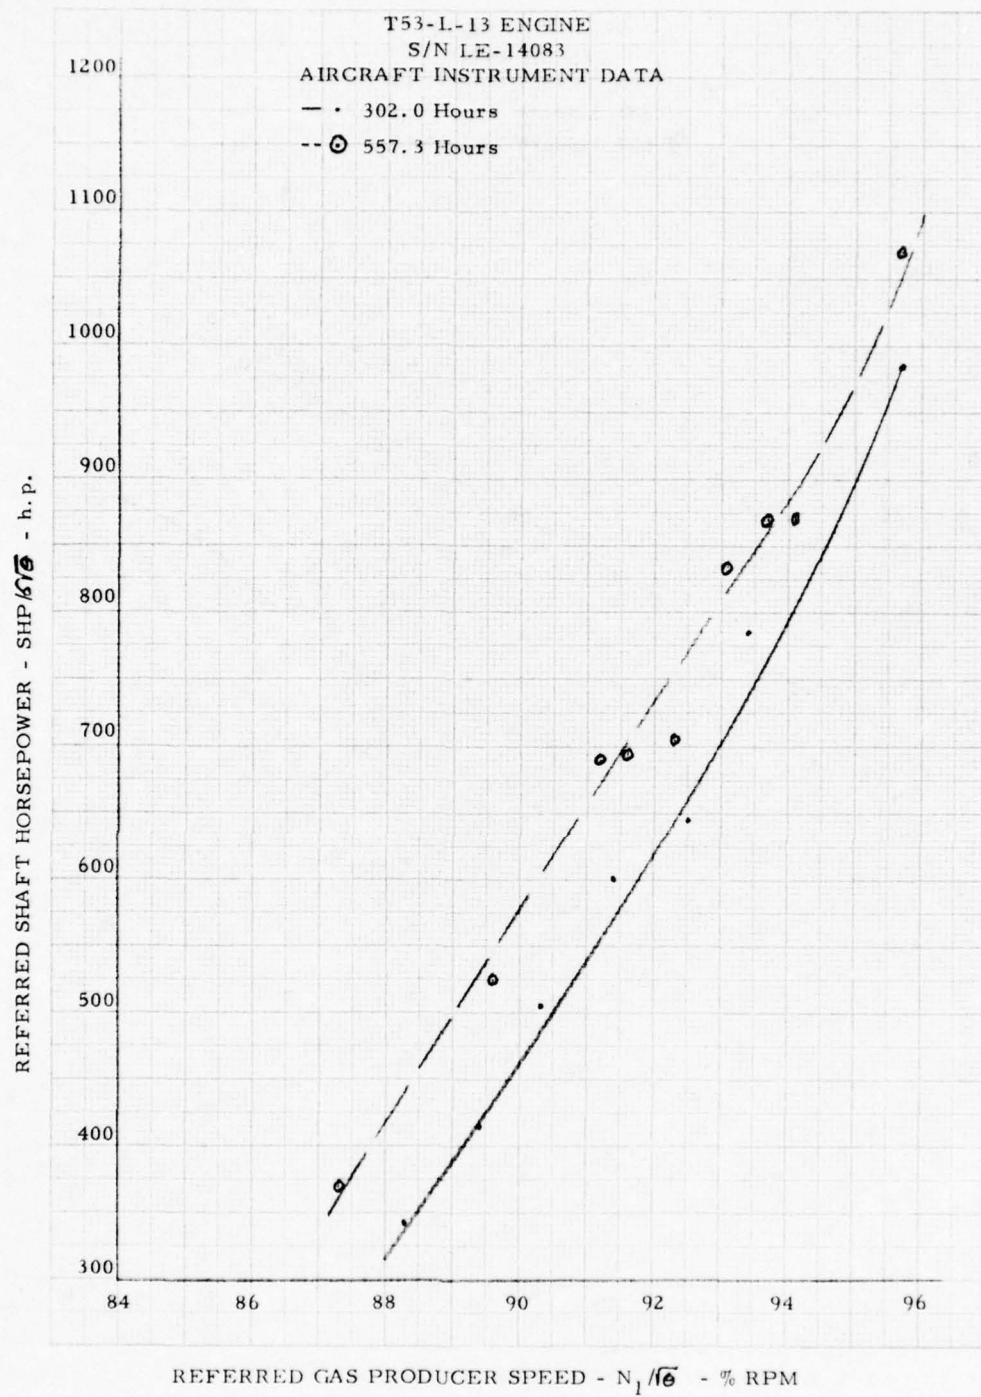
b. Figures 9, 10, and 11 show engine performance prior to removal at 557.3 hours compared to performance subsequent to reassembly after the 300-hour analytical hot-end inspection. It should be noted that the increases in EGT were evident only when EGT was referred and compared to the referred EGT immediately after reassembly of the engine at 300.0 engine hours. The indicated EGT observed by the pilots in no way alerted them to an increase in EGT.

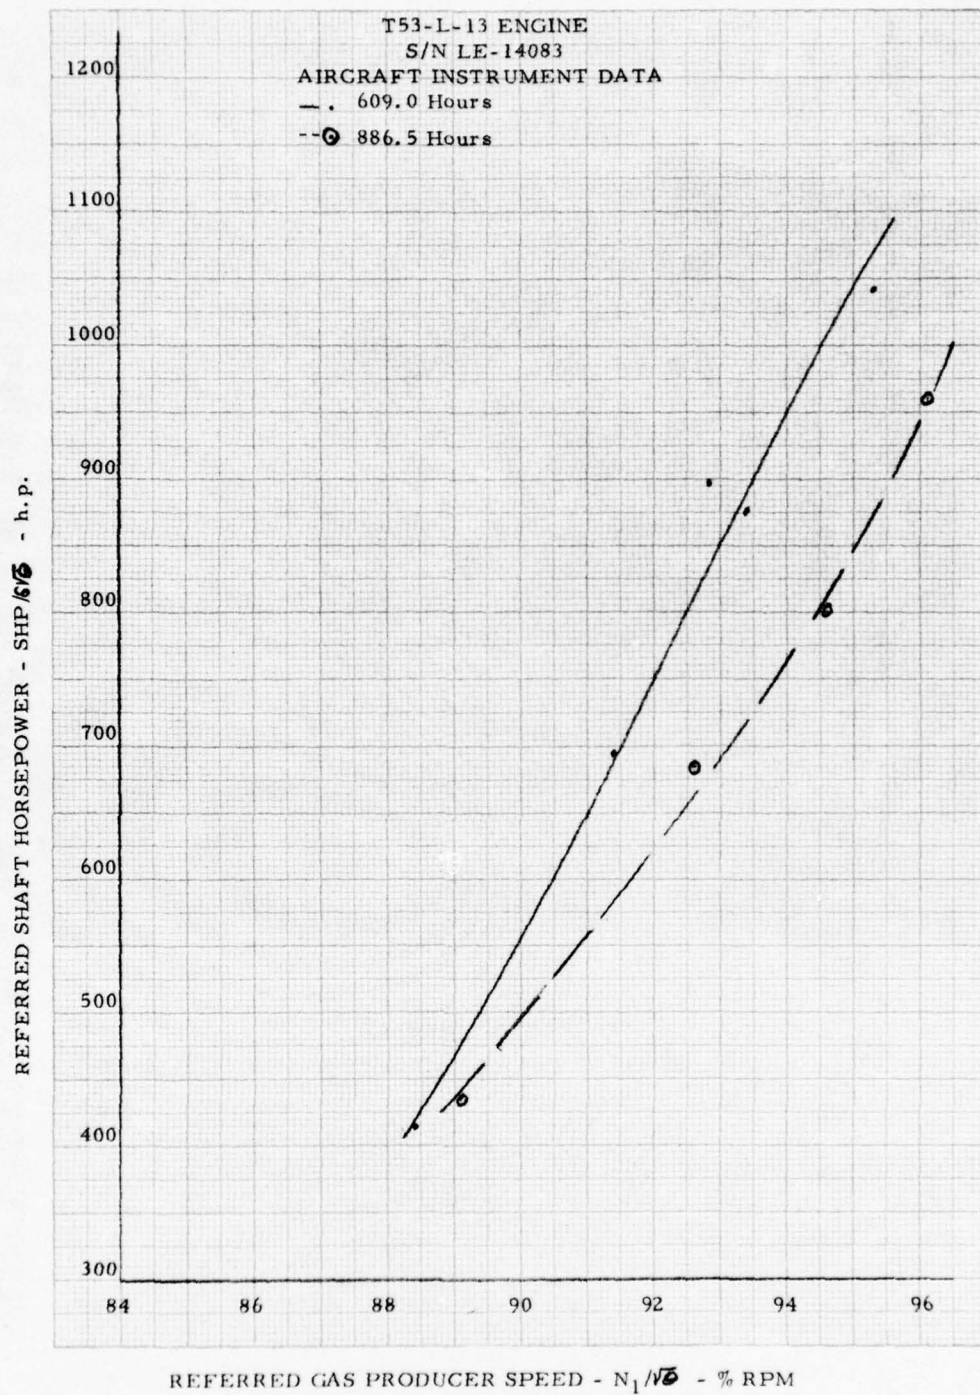
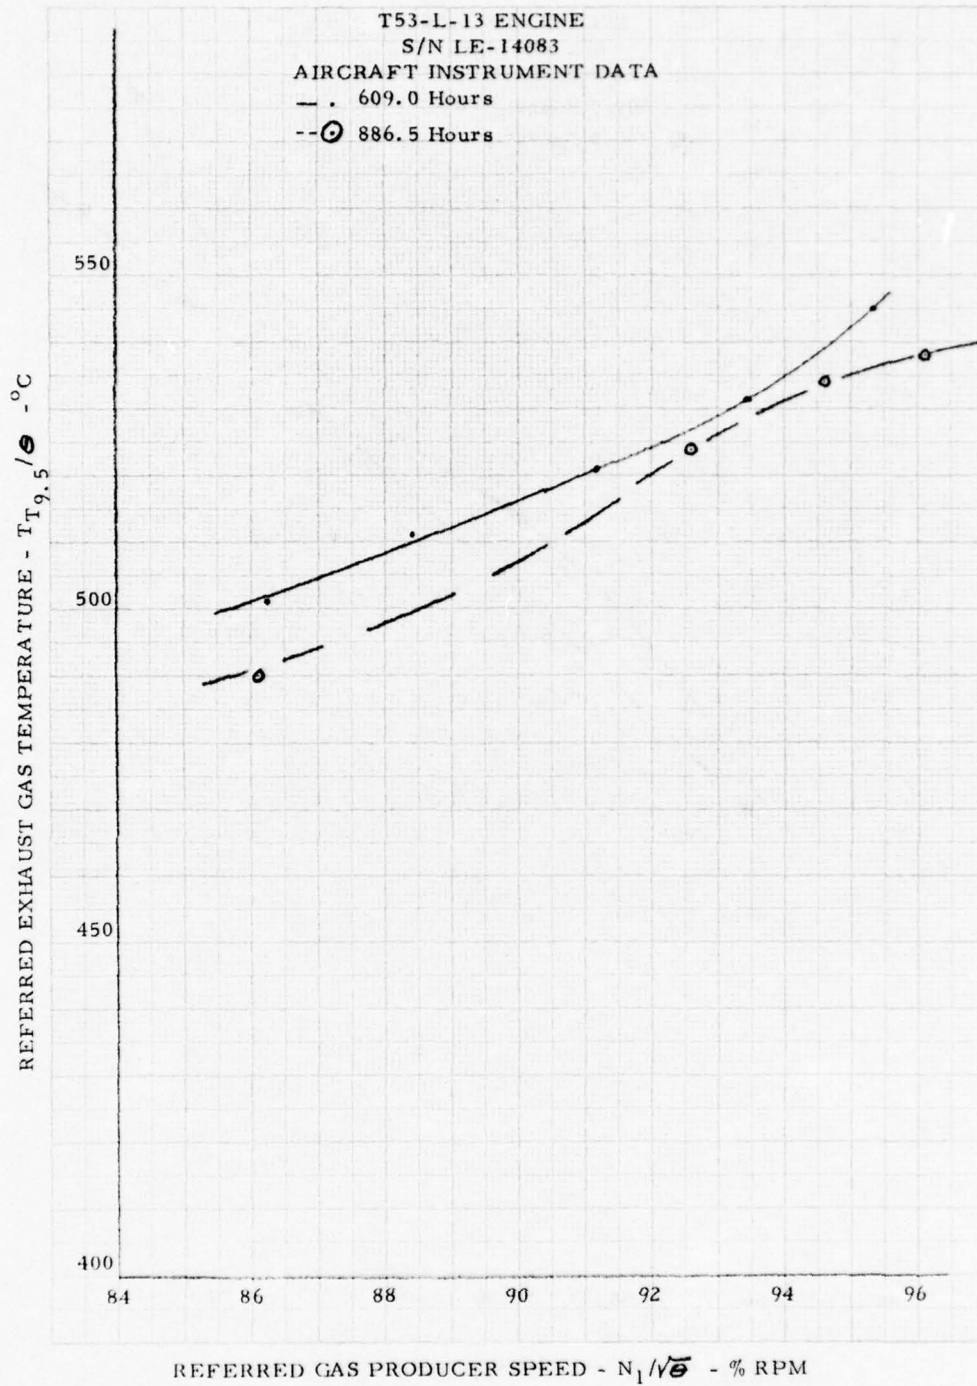
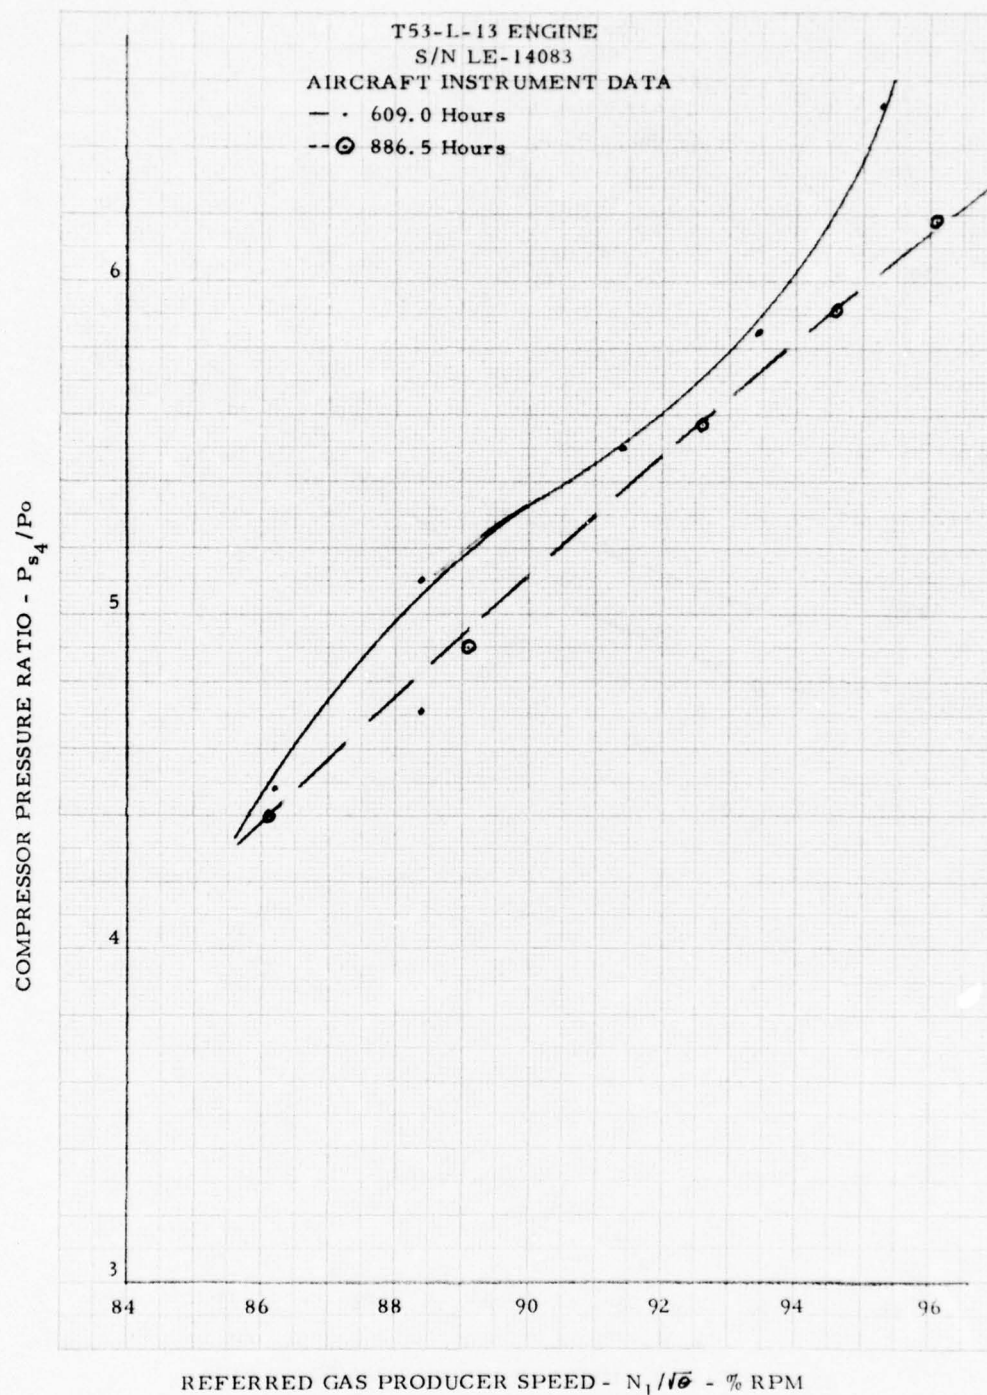
b. Figures 18, 19, and 20 show engine performance prior to removal at 897.3 hours compared to performance subsequent to reassembly after the 557.3-hour analytical hot-end inspection.

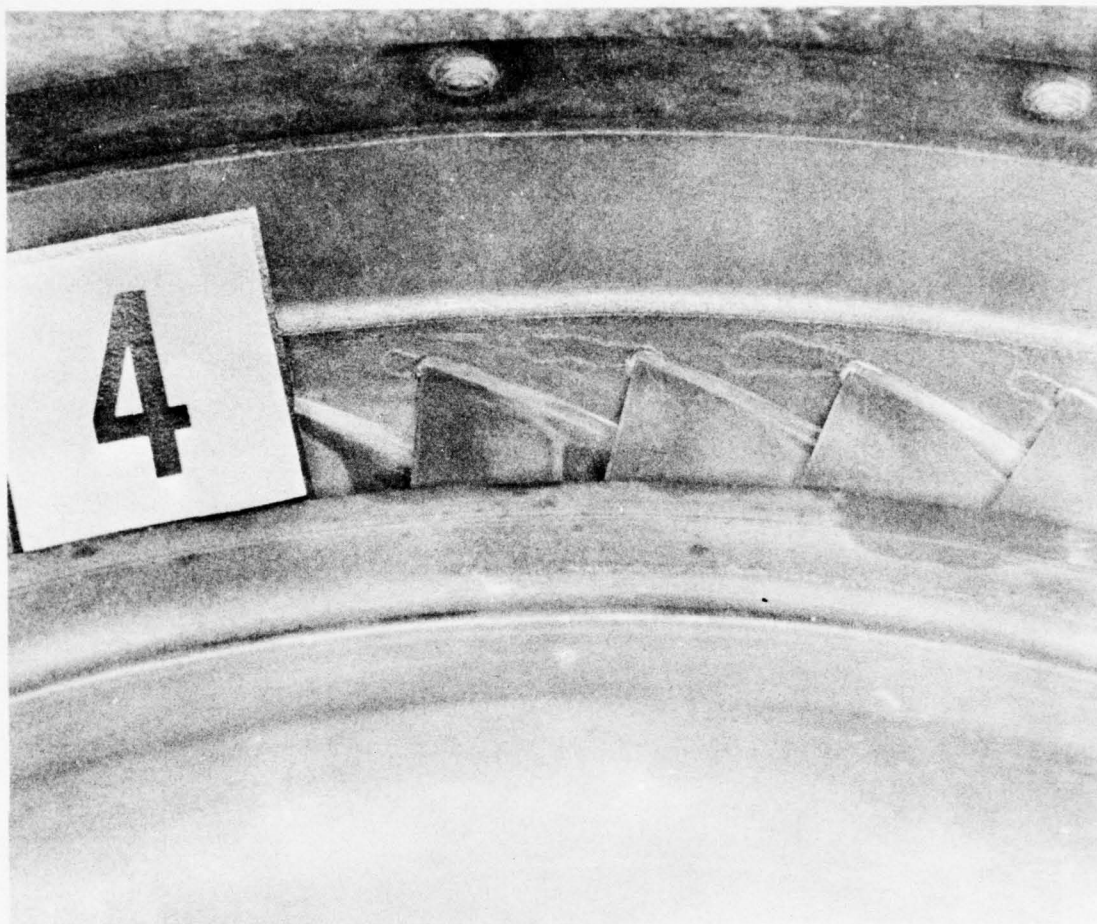
Figure 22.

<u>Nomenclature</u>	<u>FSN and P/N</u>	<u>Component</u>	
		<u>Hours</u>	<u>Damage Exceeding TB</u>
			21). Cracks extended into the outer shroud from the trailing edge brazement of 15 vanes circumferentially up to a distance of 3/8 inch into the outer shroud (figure 22).
Second-Stage GP Nozzle	2840-925-9665 1-120-000-06D	897.3	Three cracks extending across inner shroud with up to 1/2 inch of cracking in vane brazement (figure 23). Two of these cracks extended into both the front and aft supports. One extended only into the front support. The cracks extended between 7/32 and 25/32 inch into the forward inner support and between 3/8 and 1/2 inch into the aft inner support (figures 24 and 25). Thirty-nine vanes had brazement cracks extending 5/16 inch in the outer shroud at the leading edge. At 17 vanes, these brazement cracks extended axially up to 5/32 inch into the outer shroud (figure 26).
First-Stage PT Nozzle	2840-944-7296 1-190-000-09C	897.3	All vanes had cracks of up to 7/16 inch in the vane brazements in the outer shroud at the leading edge. At one vane

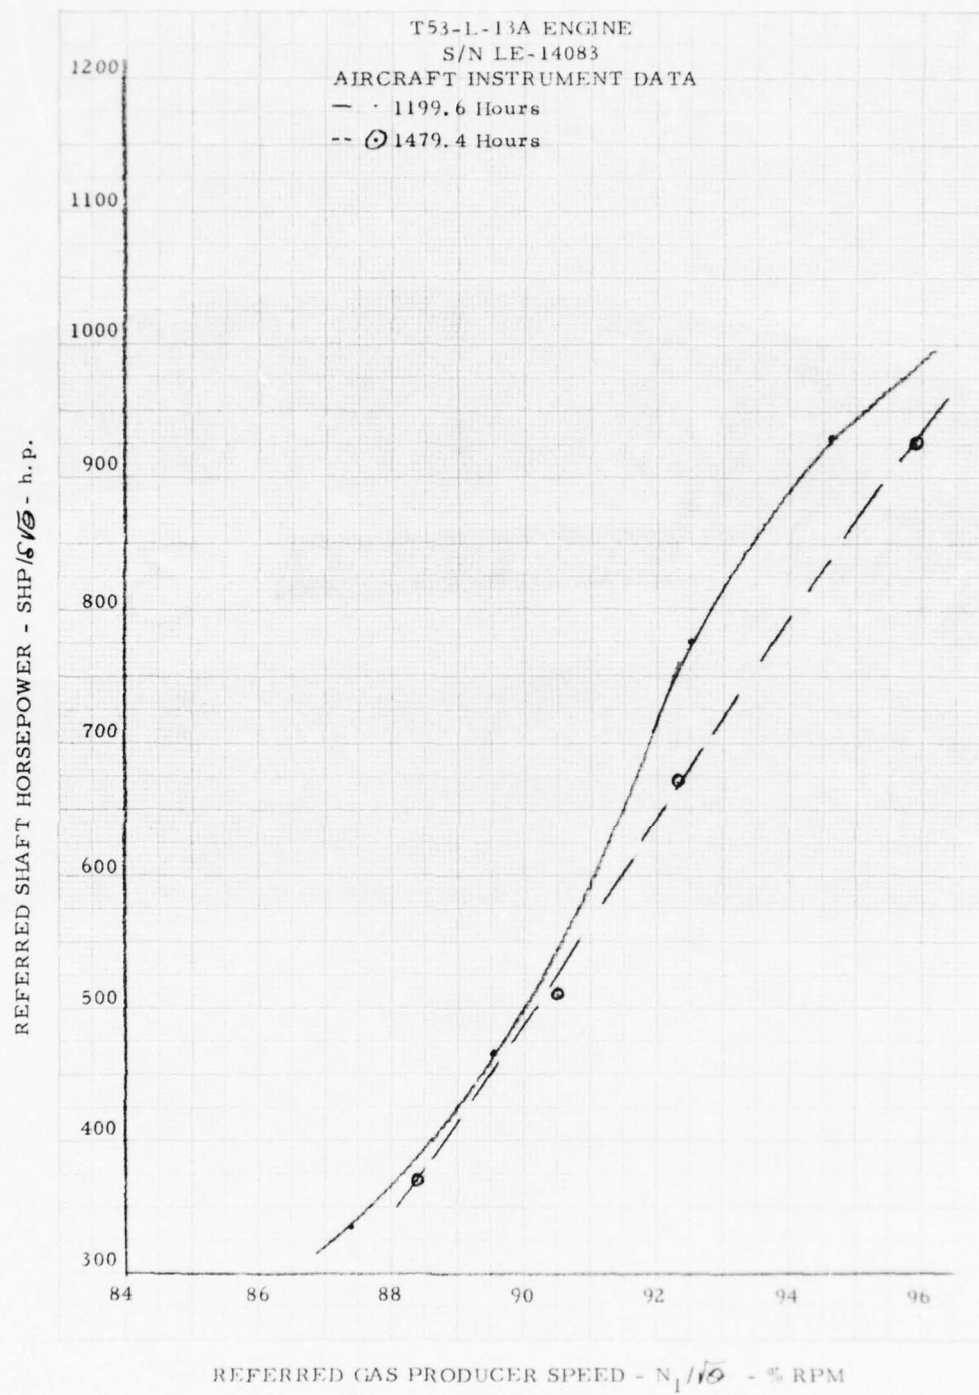
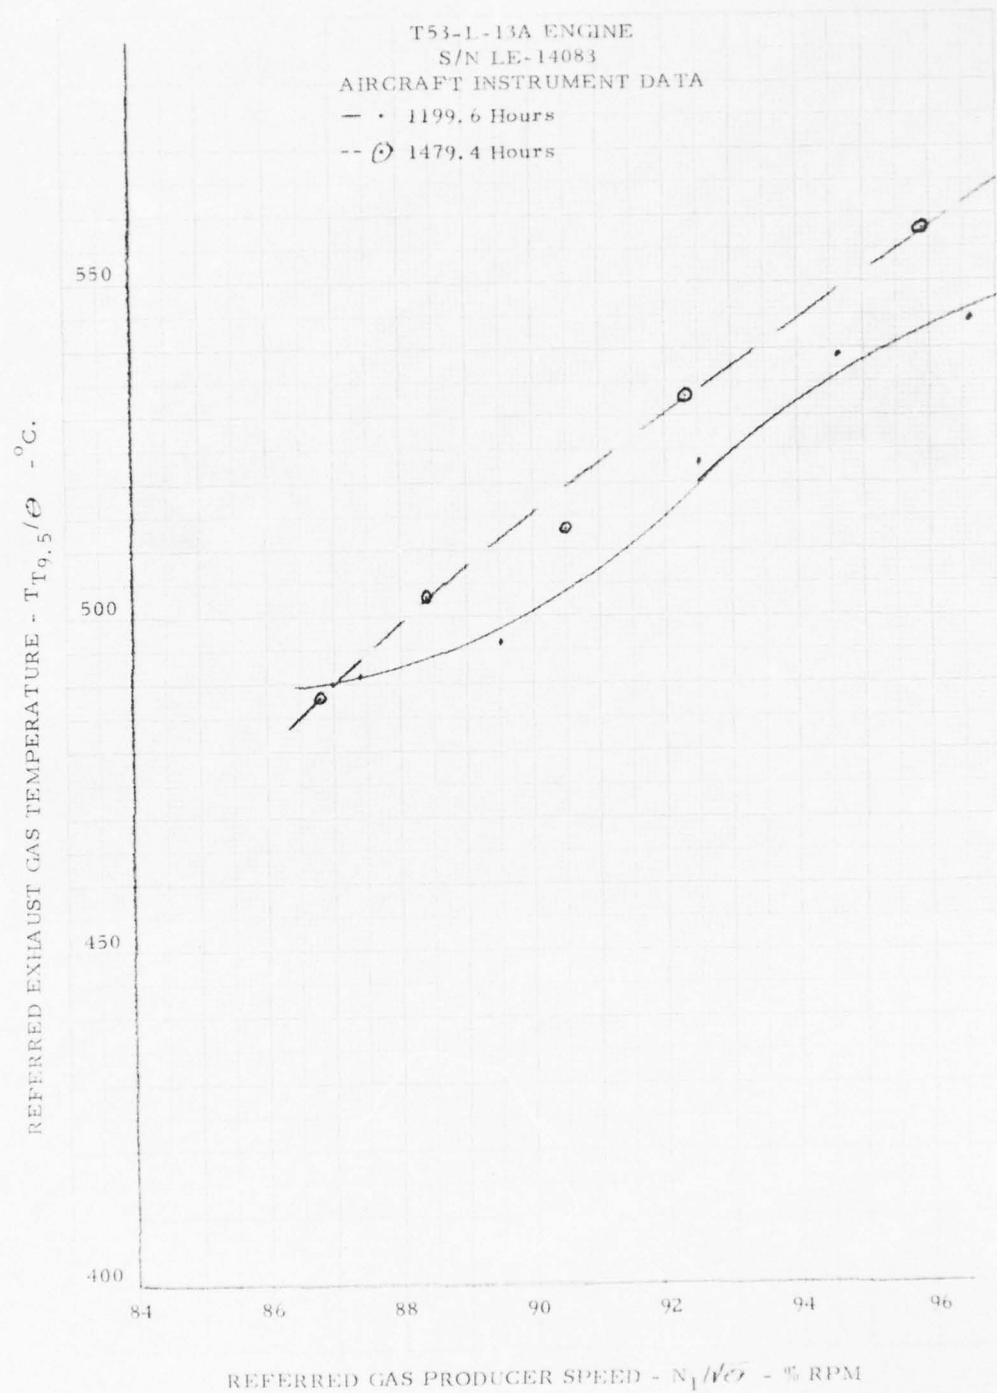
b. Figures 40 and 41 show engine performance prior to removal at 1,500.7 hours compared to performance subsequent to reassembly after the 1,199.3-hour analytical inspection.

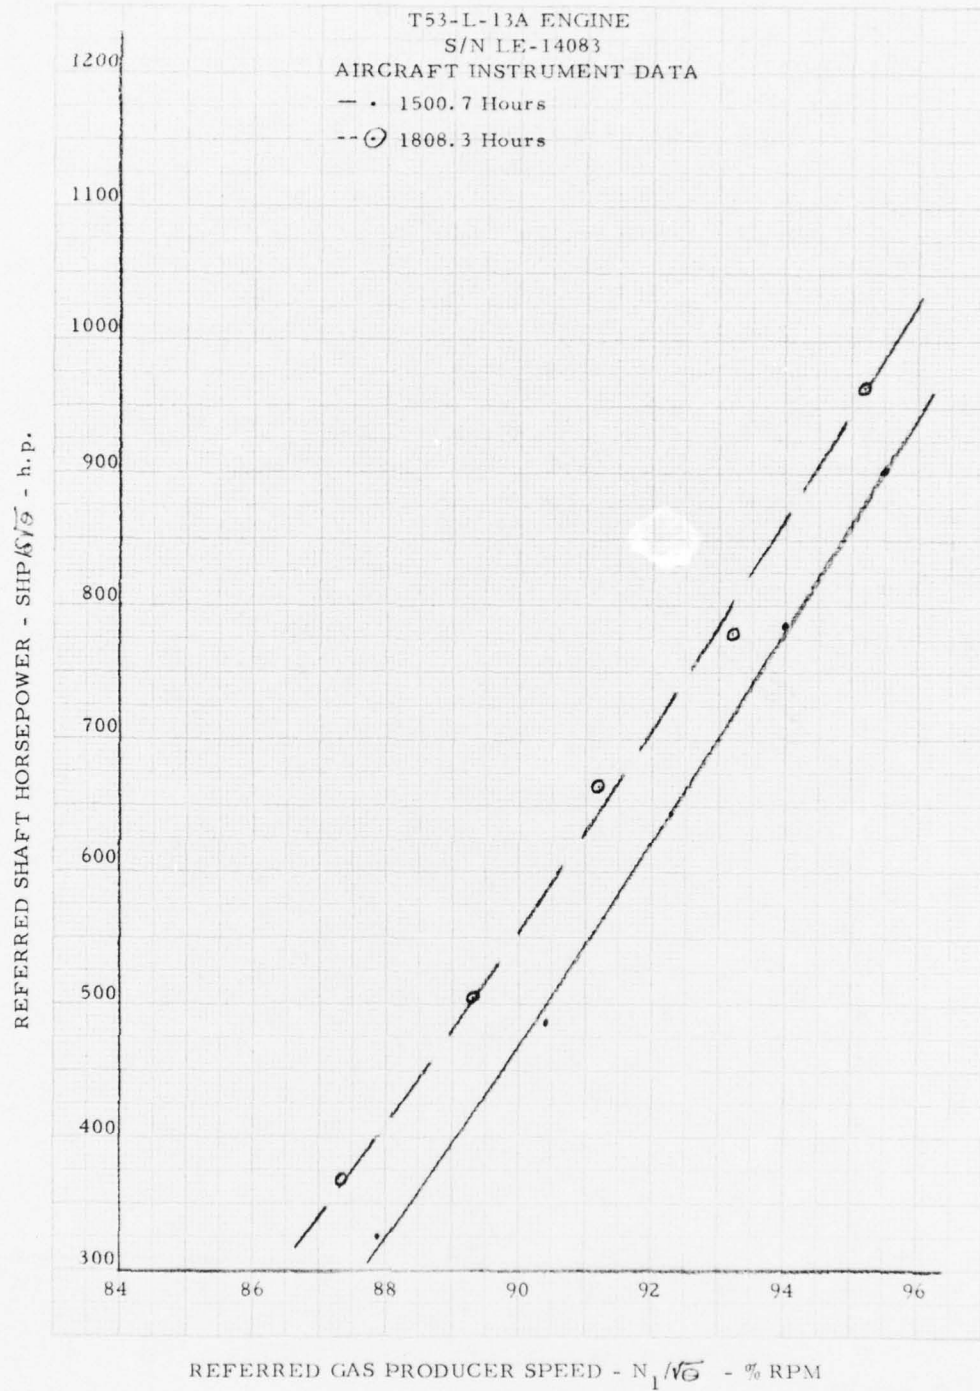
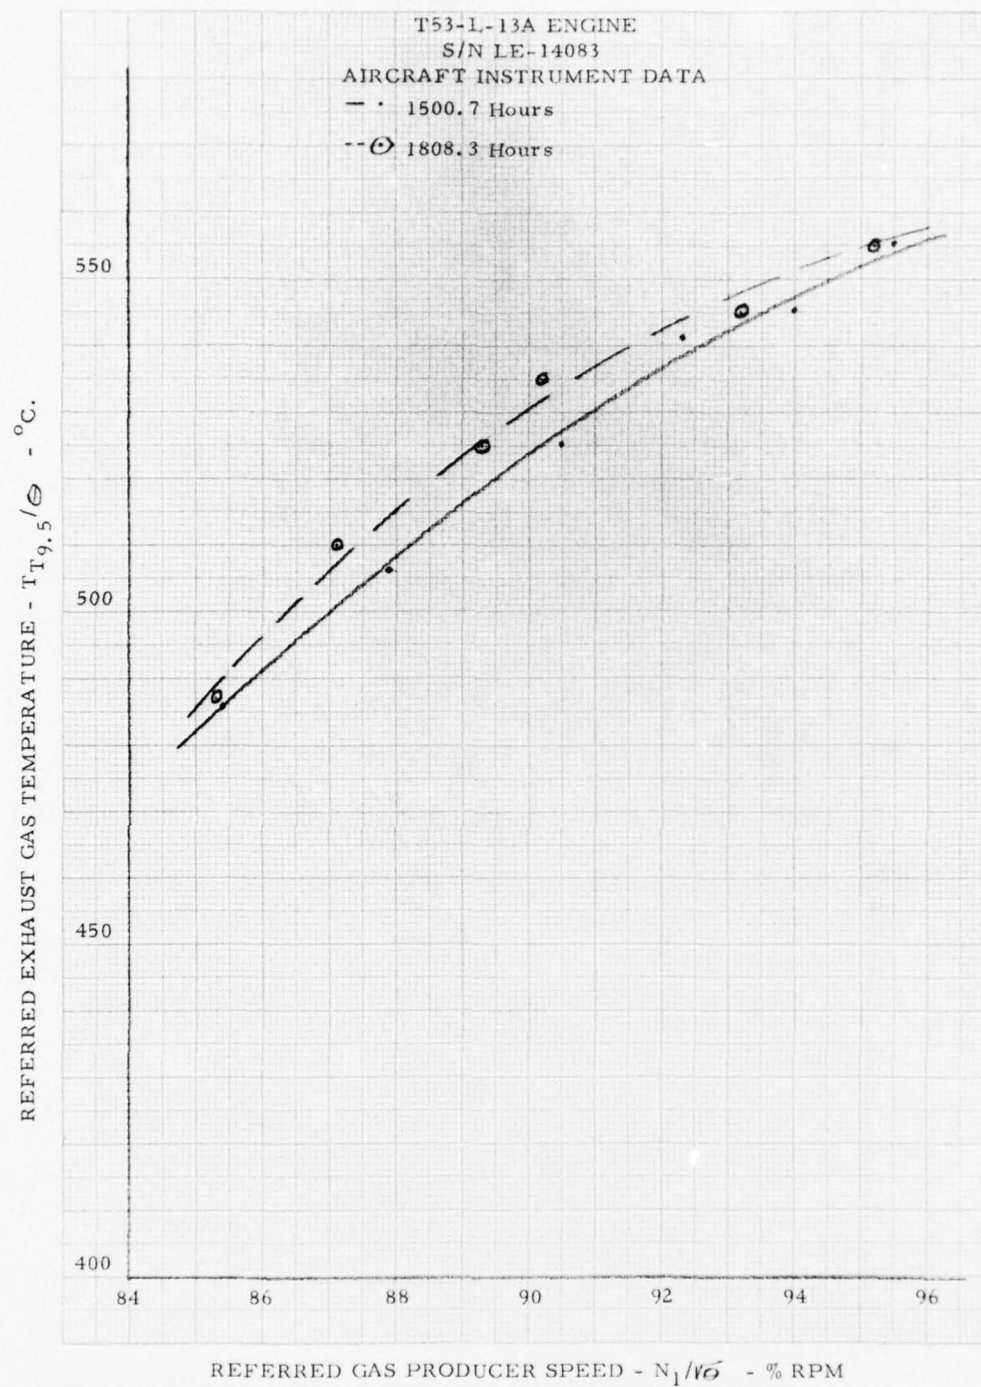
b. Figures 43 and 44 show engine performance prior to removal at 1,808.3 engine hours compared to performance subsequent to reassembly after the 1,500.7-hour analytical hot-end inspection.

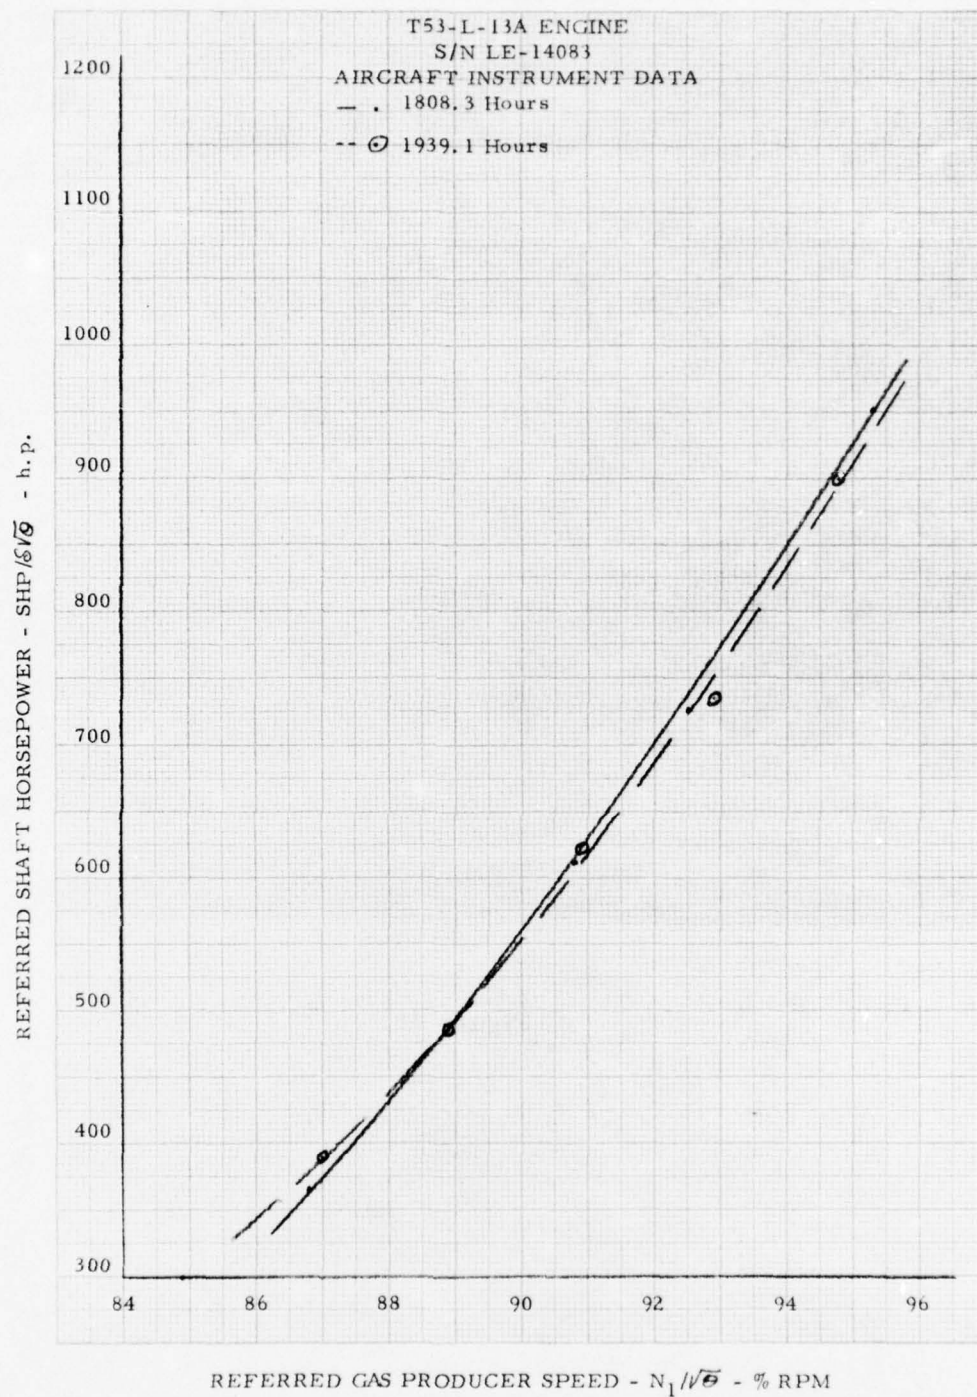
Figure 46.

b. Figures 46 and 47 show the engine performance just prior to the compressor disc failure as compared to the performance after the 1,808.3-hour inspection. Figures 48 and 49 show the change in engine performance due to use and nozzle change during the 1,839.1 hours of operation at the USAAVNTBD.
